PISC III RESULTS ON ACTION 3 "NOZZLES AND DISSIMILAR WELDS"

PH. DOMBRET
AIB-Vinçotte
R&D Department
Avenue du Roi 157
B-1060 Brussels
Belgium

ABSTRACT. Action 3 was initiated in 1986, in the framework of the PISC III programme [1], to evaluate the actual NDE capability for the structural integrity assessment of safe-ends in power plants.

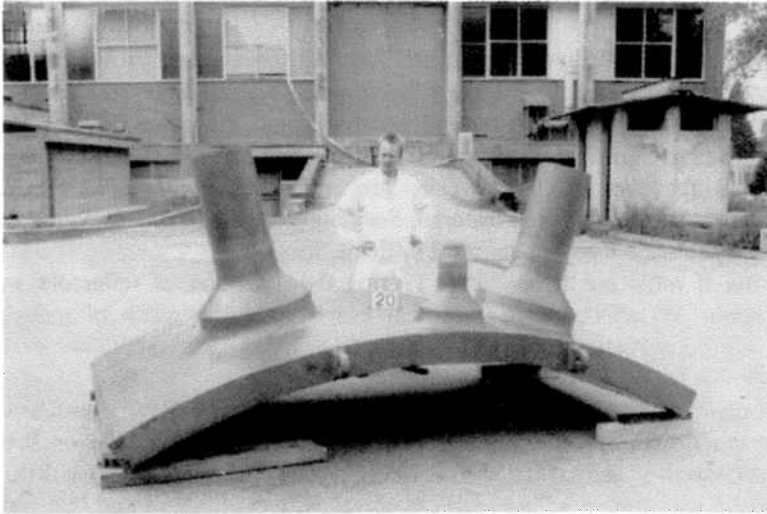
Fig. 1 - Assembly 20 (21 & 22)

Assembly 20 (Fig. 1) was based on a BWR pressure vessel shell containing two recirculation system inlet nozzles. An Inconel safe-end and a portion of carbon steel pipe was welded, with Inconel, on both nozzles, which are referred to as 21 and 22. As it turned out subsequently, the nozzle ends had been originally prepared by machining through older welds, resulting eventually in the repair-like structure shown in Figure 2.

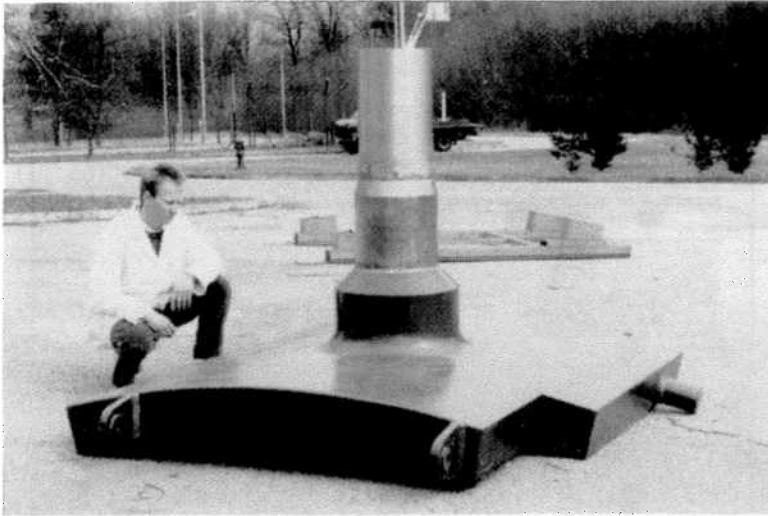
Fig. 3 - Assembly 24

Assembly 24 is a mockup of a BWR safe-end (Fig. 3). The inside surface of the forged stainless steel safe-end presents a realistic profile, including the thermal sleeve weld. The coolant pipe section was made from wrought stainless steel.

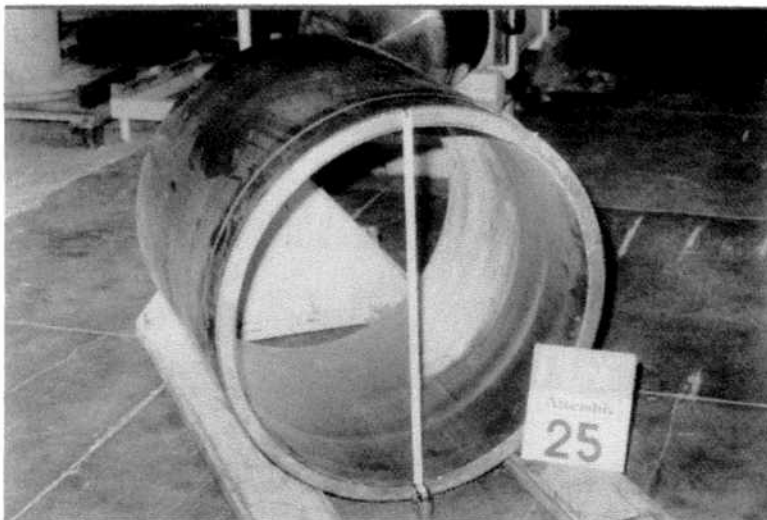
Fig. 4 - Assembly 25

Assembly 25 (Fig. 4) represents a PWR safe-end, welded to a cast stainless steel piping end. However, as a consequence of the unavailability of suitable components, the wall thickness was no more than 40 mm, and a reduction of the inside diameter was present close to the dissimilar metal weld root.

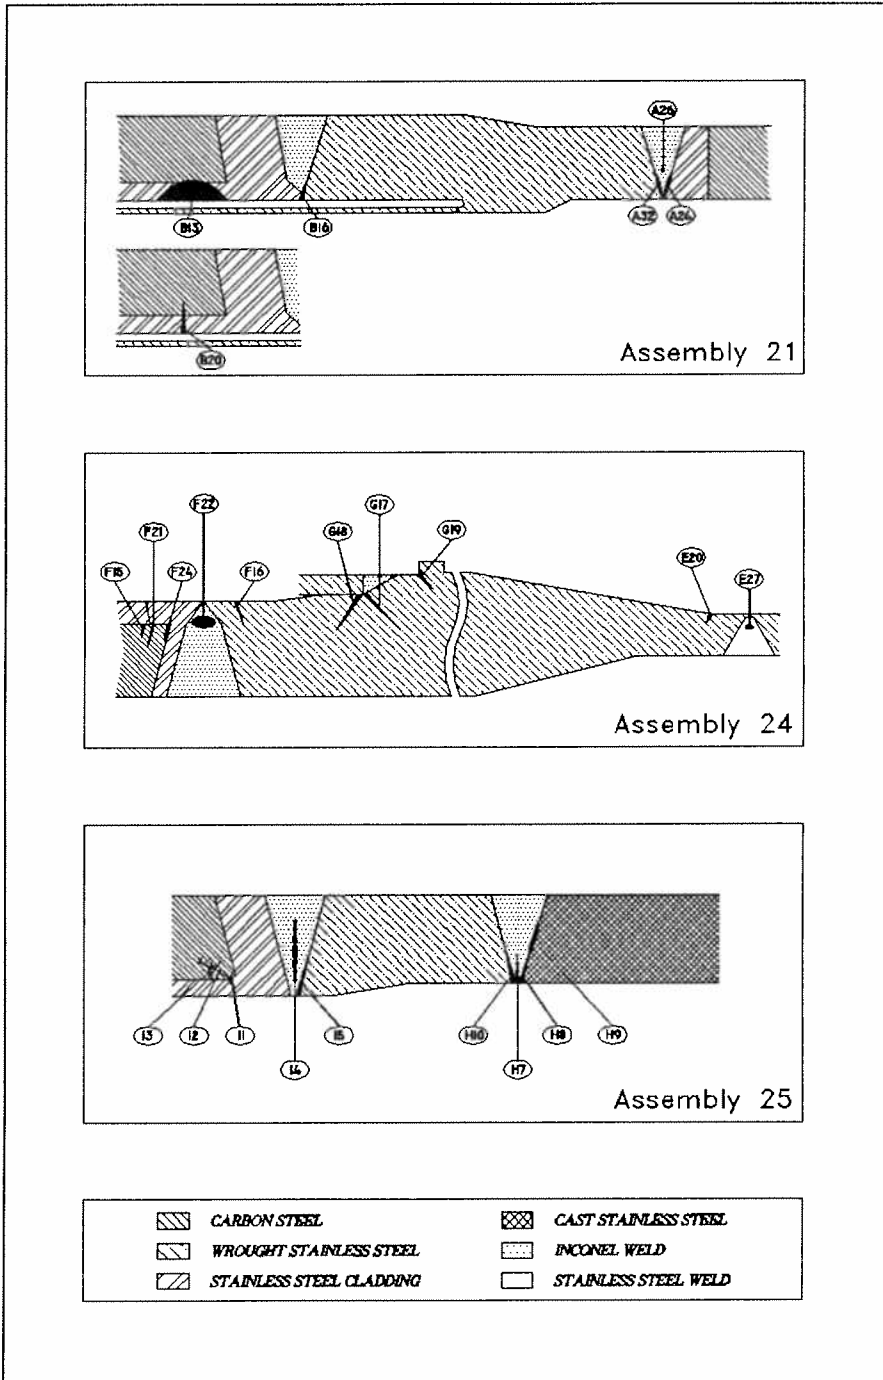
Fig. 5 - Flaw distribution in the 3 assemblies

A total of 25 flaws had been intentionally introduced in the assemblies : 3 in the thermal sleeve area of Assembly 24, 13 in the dissimilar metal welds, and 9 in the homogeneous welds. As the depth dimensions ranged from 10 to 50% of the wall thickness, only few of them were acceptable according to ASME XI article IWB-3514 [6]. Figure 5 displays their distribution in three assemblies ; no flaw was intentionally introduced in the dissimilar weld nor in the homogeneous weld of Assembly 22.

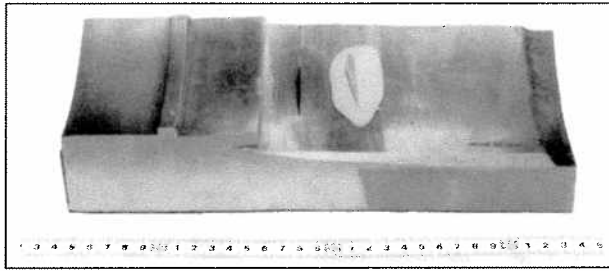
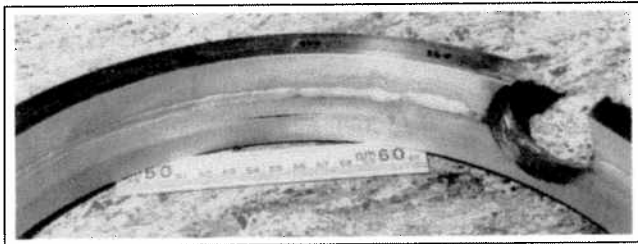
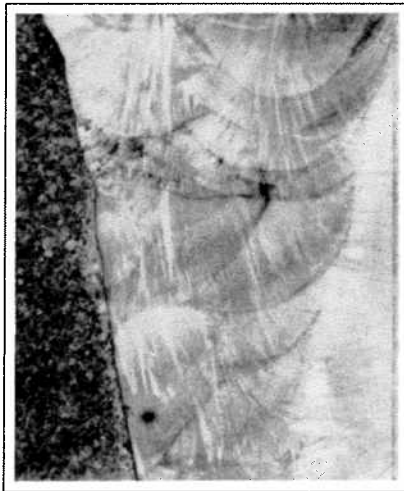
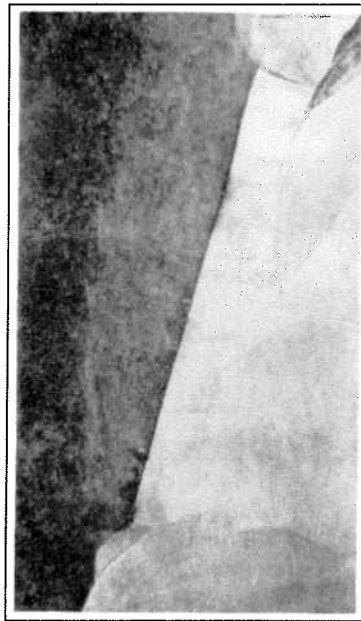
Fig. 6 - Typical flaws

Several fabrication processes were used to introduce the flaws. Planar reflectors were obtained either by fine machining and electro-etching, as in many other PISC exercises, or by a complex technique to be performed during the specimen welding [7] ; Figure 6 shows some typical examples. Care was taken to avoid detectable discontinuities of the metallurgical structure in the vicinity of the flaws.

a. machined flaws

b. Flaw I5 (Assembly 25)

c. Flaw H9 (Assembly 25)

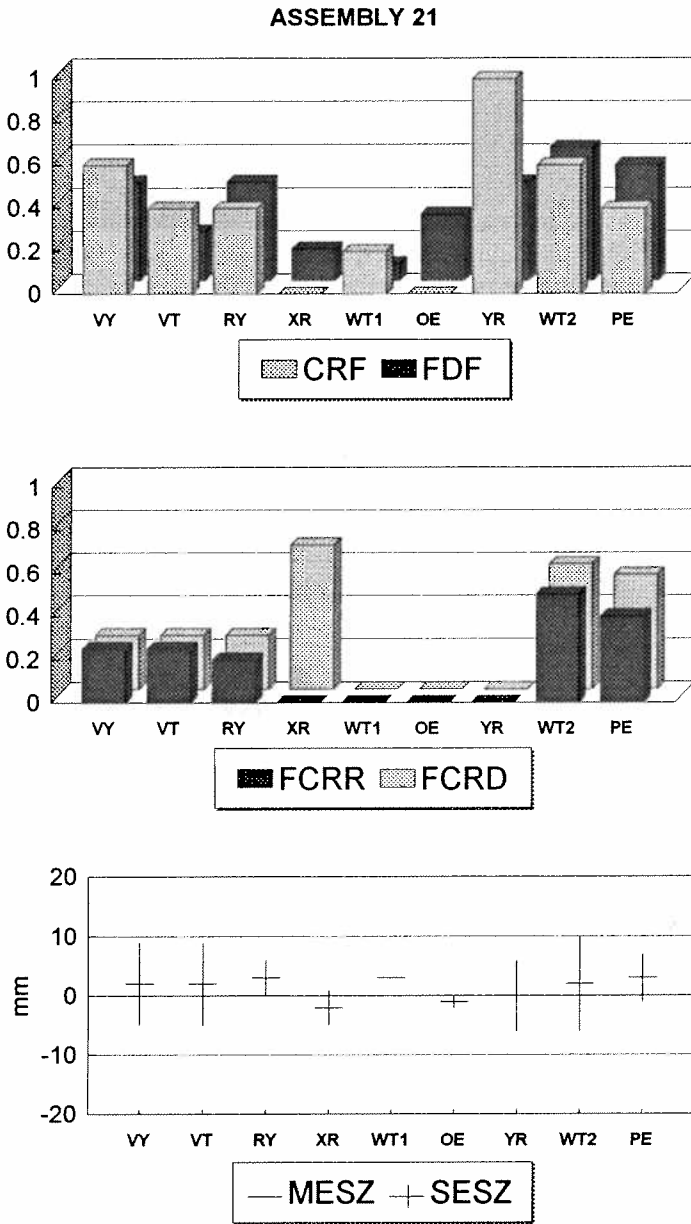
Fig. 7 - Results of all teams on Assembly 21

Figures 7 to 10 illustrate the results obtained by all participating teams. Only a few of the teams reach a flaw detection frequency of 80%, whereas a significant number of false calls are reported.

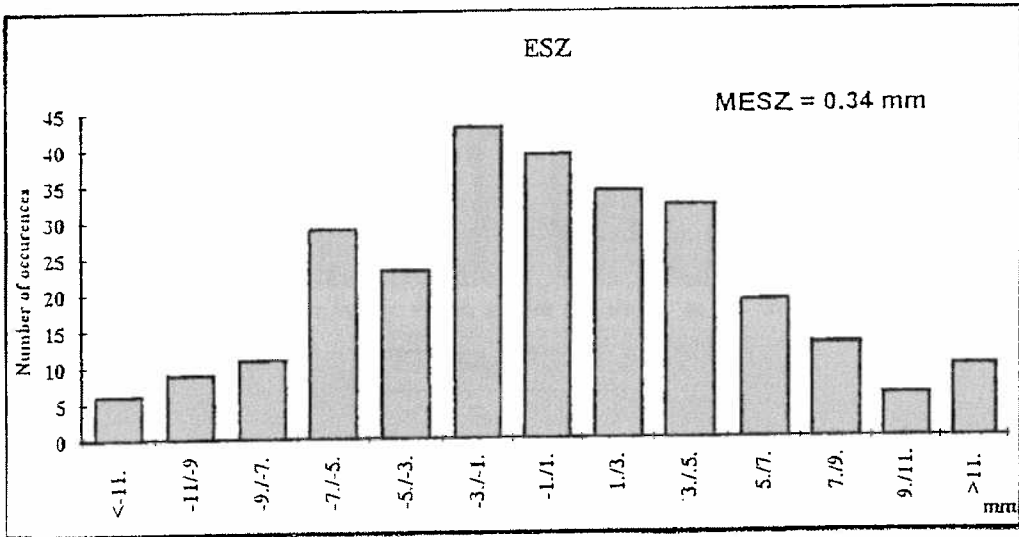
Fig. 11 - Distribution of the sizing error (all assemblies)

Regarding the capability of flaw sizing in the through-wall direction, a slight tendency to oversizing appears, on average, but the standard deviation is comparatively large. The overall dispersion of the sizing error is of the order of ± 5 mm, as illustrated by Figure 11.

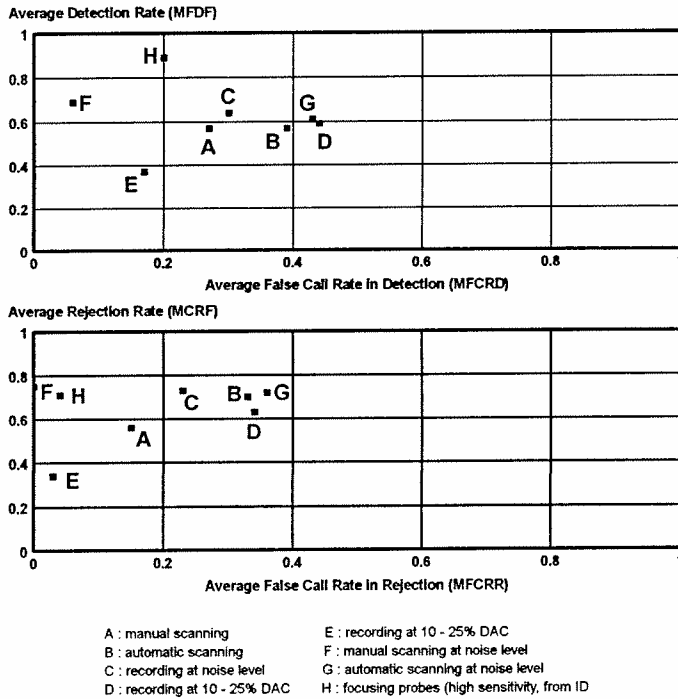
Fig. 12 - Results of inspection procedure families

Teams can be grouped in families, on the basis of key features of the procedure they implemented. Such families have been defined to investigate the influence of the procedure sensitivity, i.e. the signal recording threshold, and of the scanning mechanization. Except where specified, only ultrasonic examinations conducted from the outside surface are analyzed in this section. Figure 12 illustrates the average flaw detection and correct rejection performance of the procedure families, versus their false call scores. The overall trends arising from these diagrams are more deeply analyzed in the following.

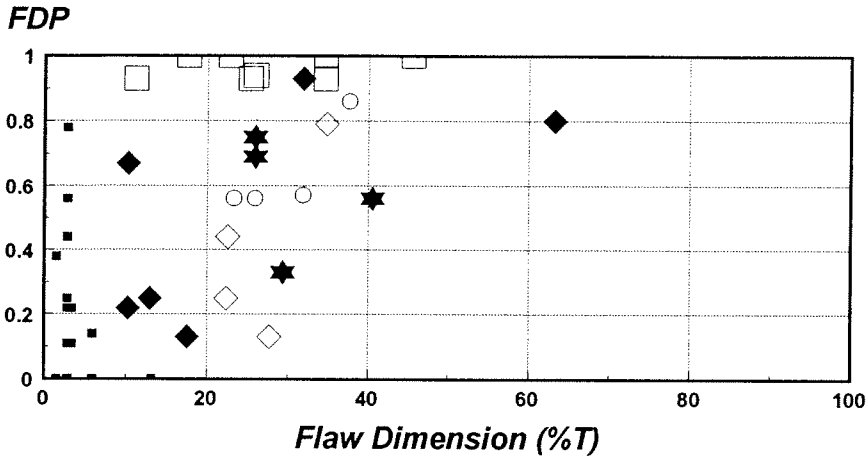
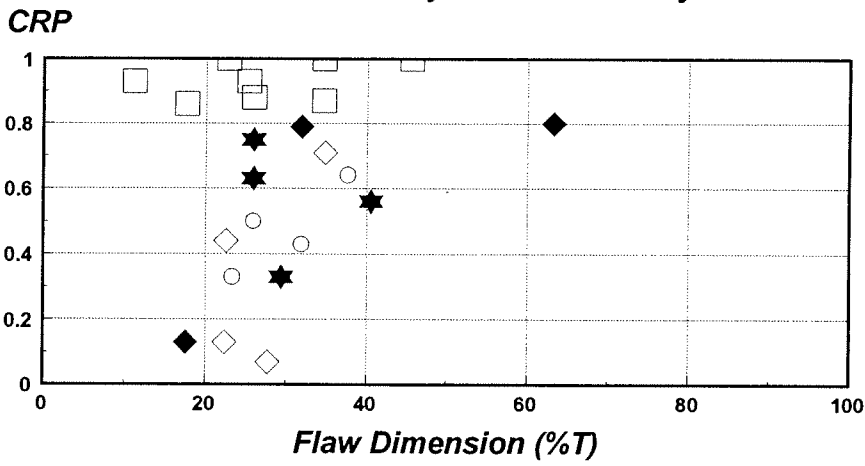
Fig. 13 - Flaw detection and rejection probability

Taking all teams in consideration, Figure 13 shows the average probability of detection and of correct rejection, for each flaw, as a function of its depth dimension (in percent of the wall thickness). Distributing flaws among categories, on the basis of their location and morphology, leads to the conclusion that the reflectors located in carbon steel or in wrought austenitic steel, far enough from welds, are much better characterized than those neighbouring or embedded in fused material. Seemingly, flaws extending within the welds or along the safe-end fusion lines appear most difficult.

Furthermore, it turns out from Figure 13 that the detection of reflectors smaller than 2 mm (i.e. about 5% of the wall thickness) lies beyond the reach of today's common technology. This observation is confirmed by additional measurements achieved by some teams after the RRT.

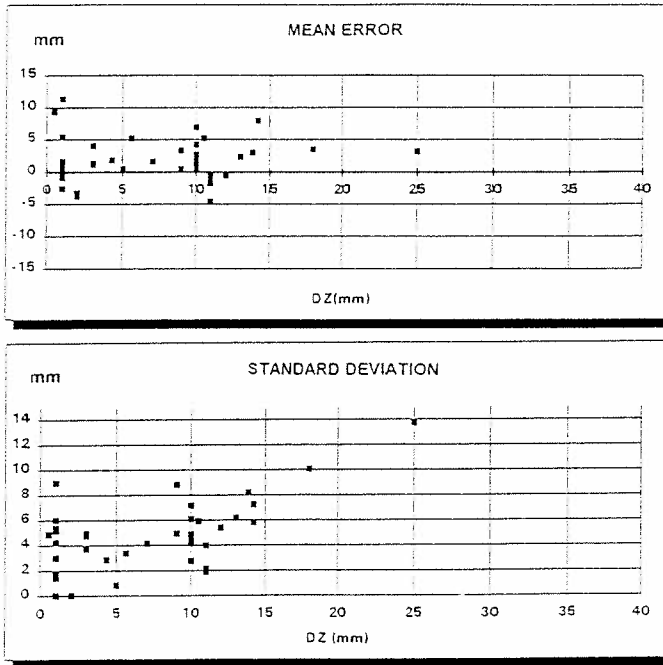
Fig. 14 - Mean error of sizing and standard deviation of each flaw

Figure 14 depicts the sizing accuracy as a function of the flaw through-wall extent. Drawing regression lines through the scatter of data leads to the conclusion that the mean error remains constant, whereas the standard deviation evidently increases with the flaw size.

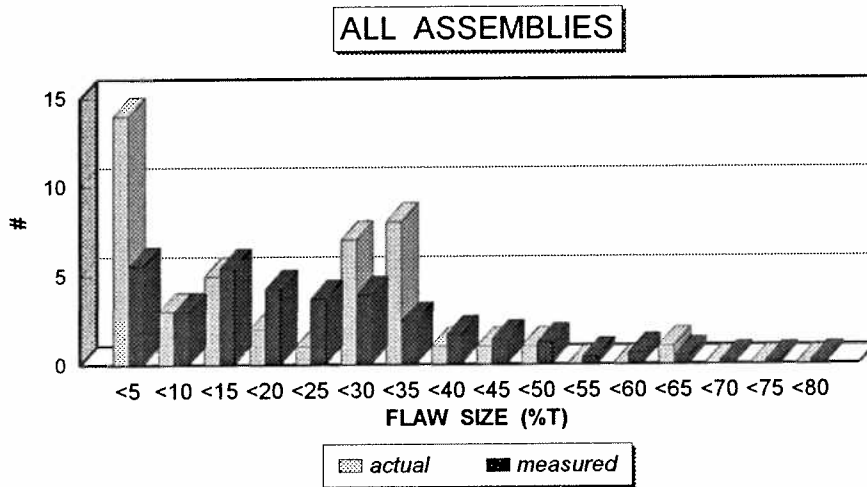
Fig. 15 - Flaw dimension distribution

A comparison was attempted between the actual flaw distribution and that reported by a virtual inspector matching the average performance of all teams (Fig. 15). Disregarding the very small flaws, the total number of declared indications is roughly correct ; the actual peak in the range of 25 to 35% of the thickness is only flattened by the flaw sizing error.
