**DEVELOPMENT OF A UT/ET PROCEDURE
FOR THE INTERNAL EXAMINATION OF
PWR MAIN COOLANT LOOP COMPONENTS**

Ph. Dombret, G. Maes - AIB-VINCOTTE (Belgium)
J. D. Davis, M. Attaar - WESDYNE (USA)

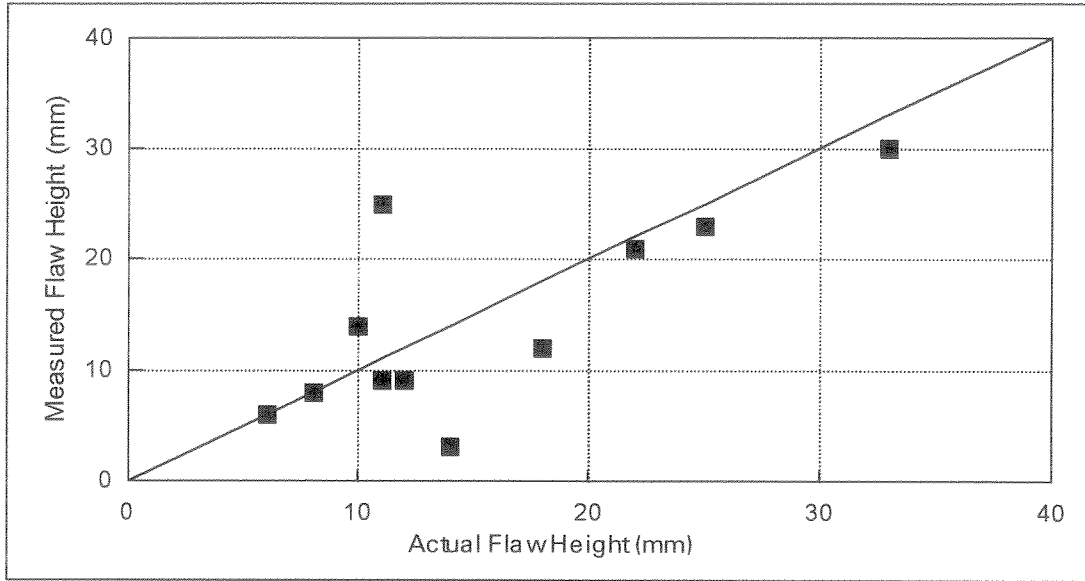
Fig. 1 - Flaw Detection and Depth Sizing Performance on Pipe-to-Elbow Specimen

Pipe-to-elbow specimen. Figure 1 shows the overall inspection performance for detection and depth sizing.

Regarding flaw sizing, Figure 1 shows that the measured height of 9 flaws differs from the actual dimension by less than a wavelength. That accuracy must be attributed to the identification of tip diffraction signals in several cases.

Significant errors are observed on two flaws. Although both of them were correctly sized by the examination carried out from the outer surface, the combination of data recorded from both surfaces led to undersize one of them, and oversize the other.
